# Floating Debris in the Low Segura River Basin (Spain): Avoiding Litter through the Irrigation Network

**Abstract:** The Vega Baja region lays on the lower course of the Segura River (southeastern Spain). It is one of the six traditional “huerta” European landscapes and has an ancient, extensive, and complex network of irrigation and drainage channels. The accumulation of floating waste causes numerous economic, environmental, and landscape problems in its irrigation infrastructures, hindering farmers’ water management practices. This work classifies and estimates the total volume of floating waste at various points along the Segura River and its irrigation channels as a first systematic approach to define and quantify the problem of floating waste accumulation. Aerial images taken by a drone were analyzed over time and a manual count of residues was performed on selected points. The results obtained show that reeds and residues of riparian vegetation represent more than 95% of the floating debris volume measured on the riverbed. Anthropogenic waste, which represents less than 5% of debris volume, was characterized, finding that plastics of domestic sources are the most abundant

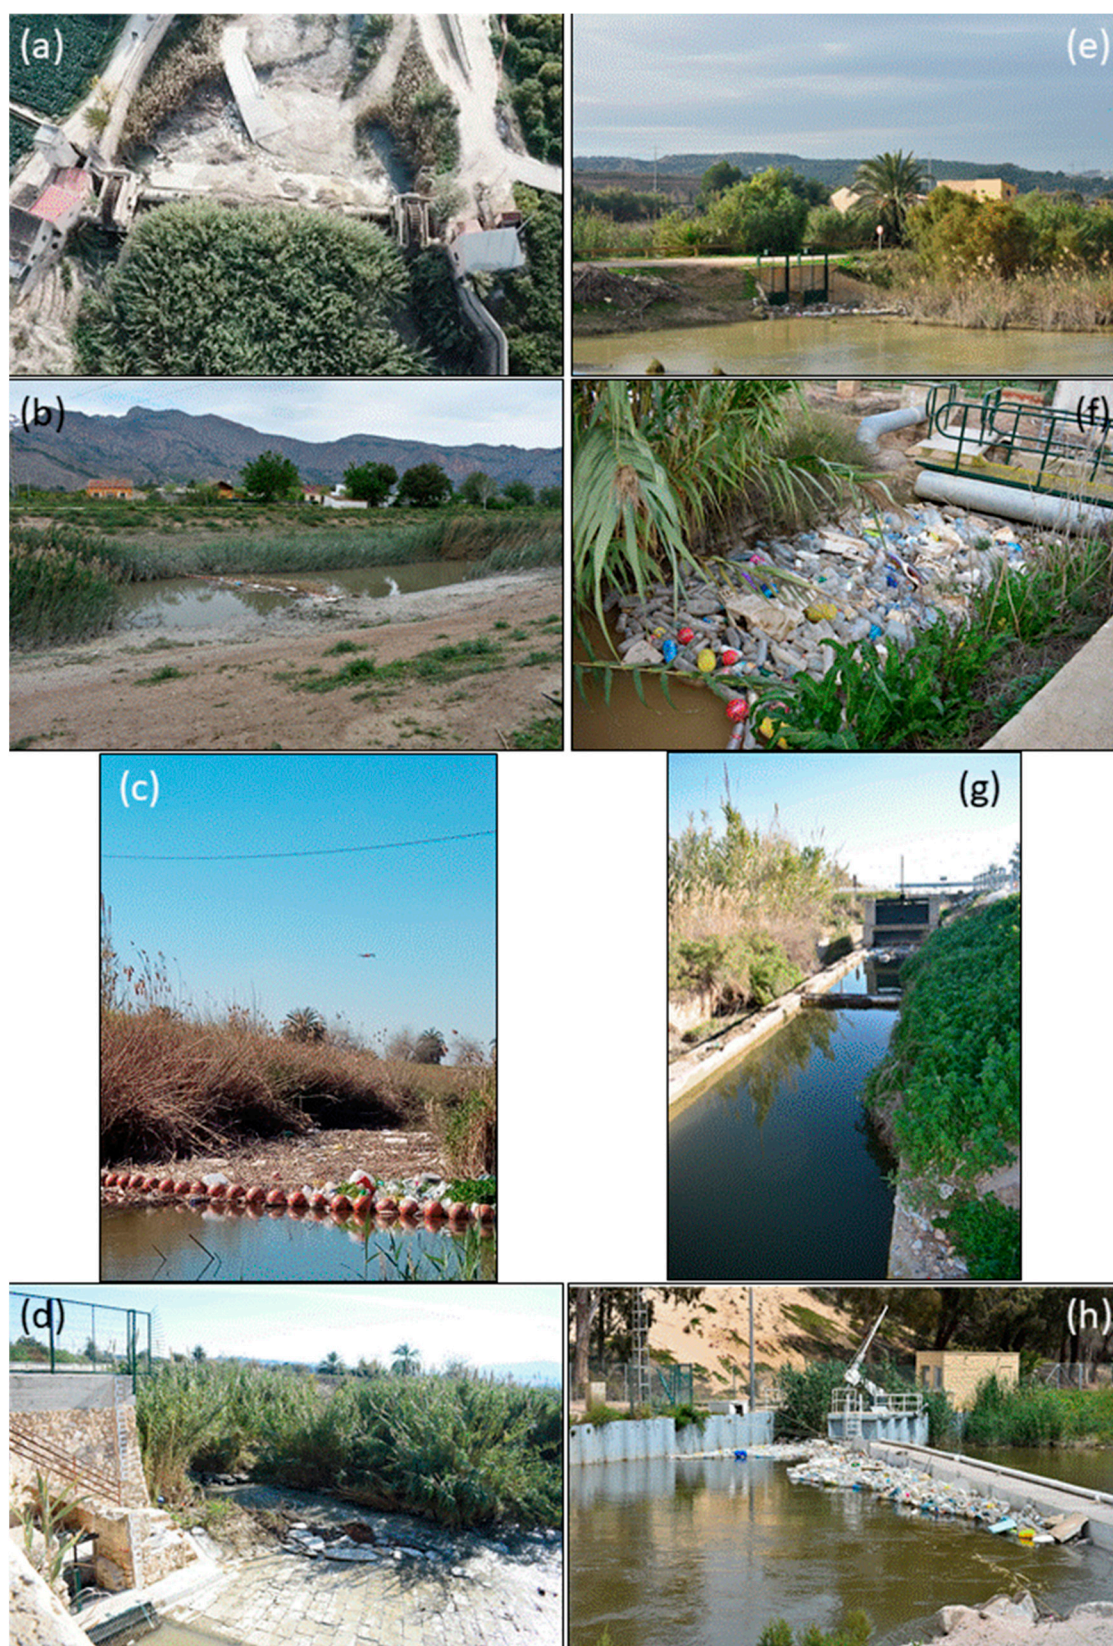
**Figure 3.** Sampling points. ID1, *Azud de las Norias* (a); ID2, boom at the *Molino de la Ciudad* (b); ID3, boom at Almoradí (c); ID4, *Azud de Alfeitami* (d); ID5, inlet of Riegos de Levante (e); ID6, *Acequia de Callosa* (f); ID7, *Azarbe de Cebadas* (g); and ID8, Guardamar floating screen (h).

The sampling points are shown in Figure 3 and described in Table 1.

ID1	<i>Azud de las Norias</i> . At that point there is a dam to derive water. It is the first singular point of the river in the Vega Baja district and thus in the province of Alicante.
ID2	Boom at the <i>Molino de la Ciudad</i> . Retention element installed by the Segura River Authority.
ID3	Boom at <i>Almoradí</i> . Retention element installed by the Segura River Authority.
ID4	<i>Azud de Alfeitamí</i> . It is a dam to derive water to the ditch of Almoradí.
ID5	Sluices on the inlet of <i>Riegos de Levante</i> irrigators community.
ID6	<i>Acequia de Callosa</i> , syphon at the crossing with <i>Acequia Vieja de Almoradí</i> .
ID7	<i>Azarbe de Cebadas</i> , syphon at the crossing with <i>Azarbe del Convenio</i> .
ID8	Guardamar floating screen. It is a retention system installed at the mouth of the old river to avoid the arrival at sea of floating debris that comes from the drainage ditches that discharge on the left bank into the last section of the river.

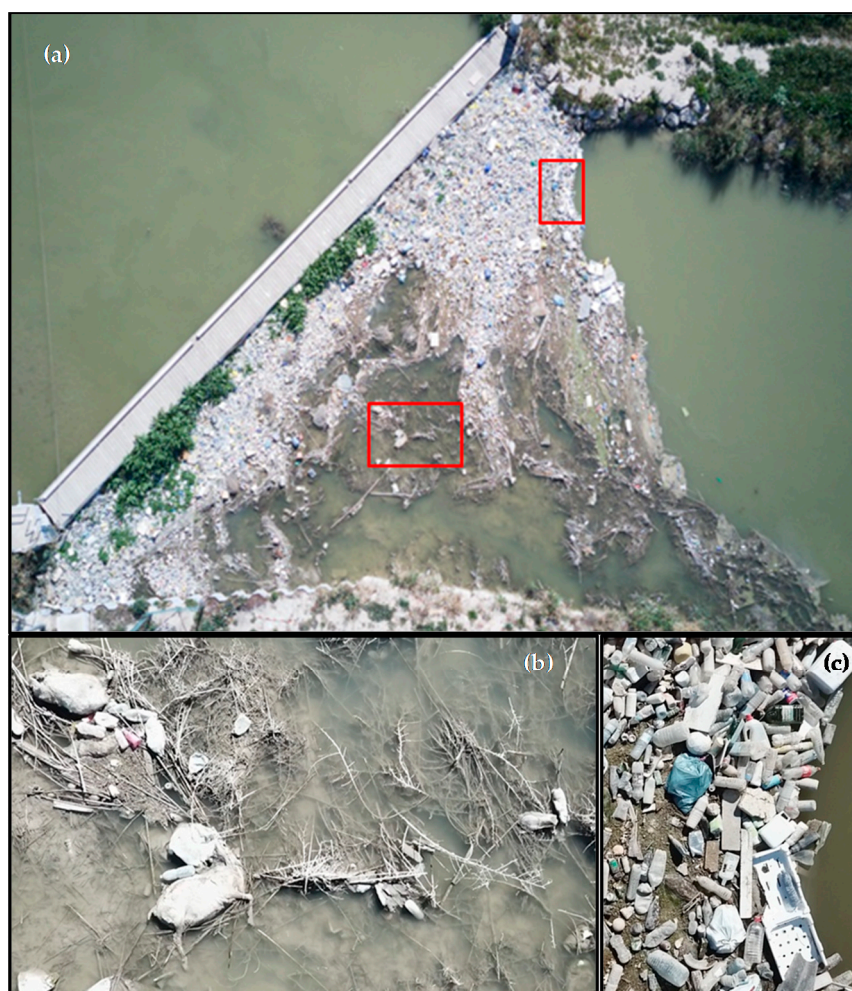
**Figure 4.** Zenith images captured from the drone: general (a) and details (b,c).

The photographs were taken from a sufficient height for the spot of floating debris to be captured in a single image. In each image, a ranging rod was photographed along the debris for scale determination. Other images were captured from lower heights to obtain better images for the waste characterization (Figure 4).

Zenith images were taken using a drone. Drone type was a DJI MAVIC PRO with a weight of 743 g, three-axis stabilization, inclination of  $-90^{\circ}$  to  $+30^{\circ}$ , and rotation of  $0^{\circ}$  or  $90^{\circ}$  (horizontal and vertical). The camera had a 1/2.3" CMOS sensor; 12.35 effective Mpixels (total: 12.71 Mpixels), and a 26 mm lens (35 mm format equivalent) f/2.2 FOV  $78.8^{\circ}$ .

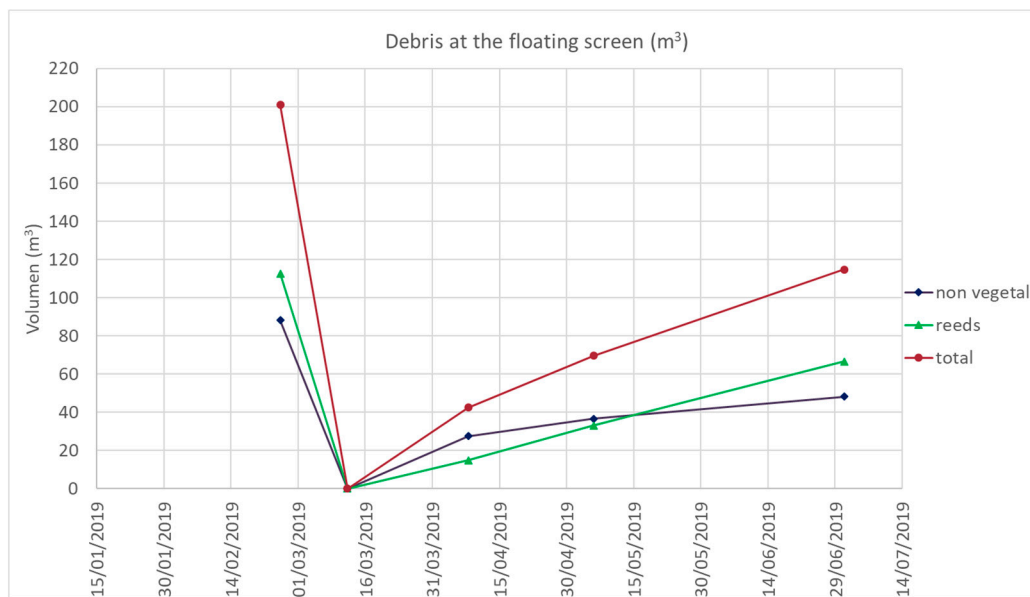
**Figure 6.** Estimated volume of debris at the floating screen, ID8.

Point ID8 is located at the mouth of the old riverbed, at the end of a short section with riverbank vegetation where a large number of drainage ditches run down the left bank. Most of the floating debris were non-vegetable waste, but there is also a considerable number of reeds (Figure 6).

Figure 6 shows a more detailed trend of floating debris accumulation at ID8, the floating boom located at the mouth of the Segura river. The cleaning of the boom by the river authority caused the well-defined decrease observed at the end of March. From that date onwards, the accumulation of floating debris increased continuously along time, without noticing the effect of the April precipitations.
